Range Environmental Vulnerability Assessment

5-Year Review Report

Marine Corps Air Station Miramar, California

June 2013
06285037.0000

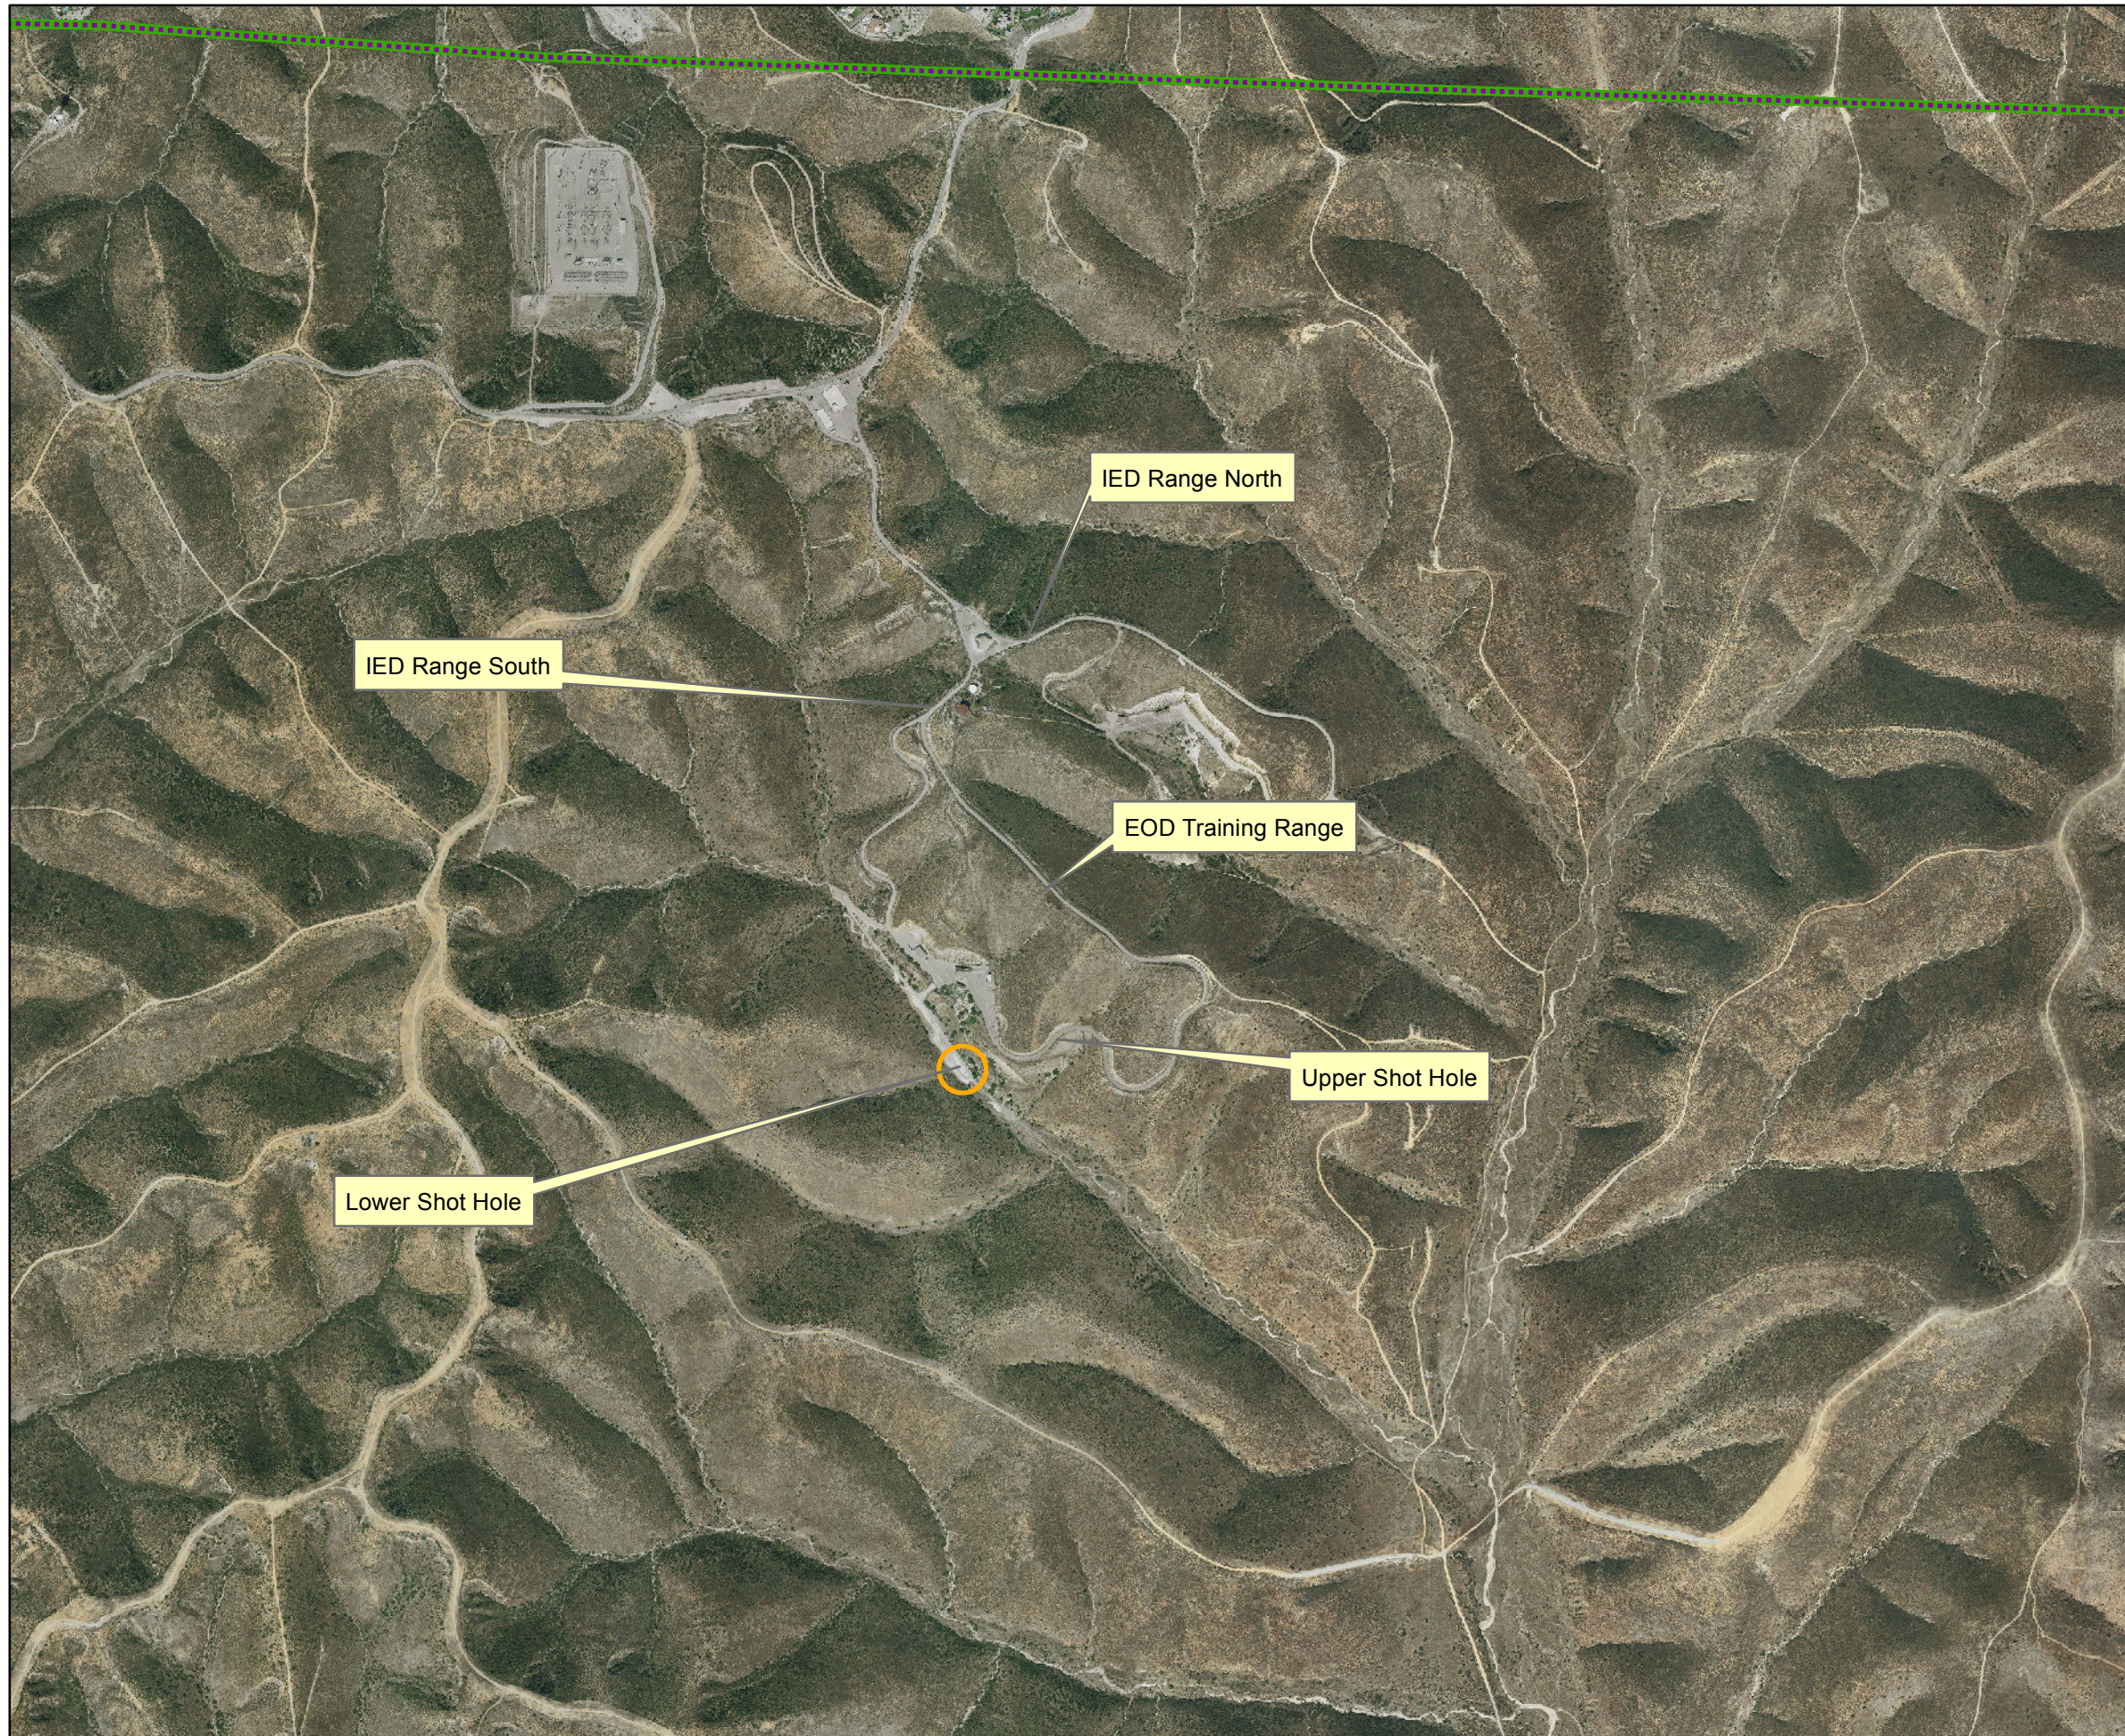
REVA
Figure 3-2
MC Loading Areas

HE and perchlorate were evaluated at EOD Training Range MC loading area; lead was evaluated at the EOD Training Range MC loading area and all nine SARs. Calculation of representative annual expenditure estimates at the ranges was performed to help characterize MC loading. The recorded totals by DoDIC for applicable years were averaged together, with all fractional values conservatively rounded up to the next whole number. The specific methodologies and assumptions used to conduct the MC loading at each loading area are detailed in **Section 6**, as applicable.

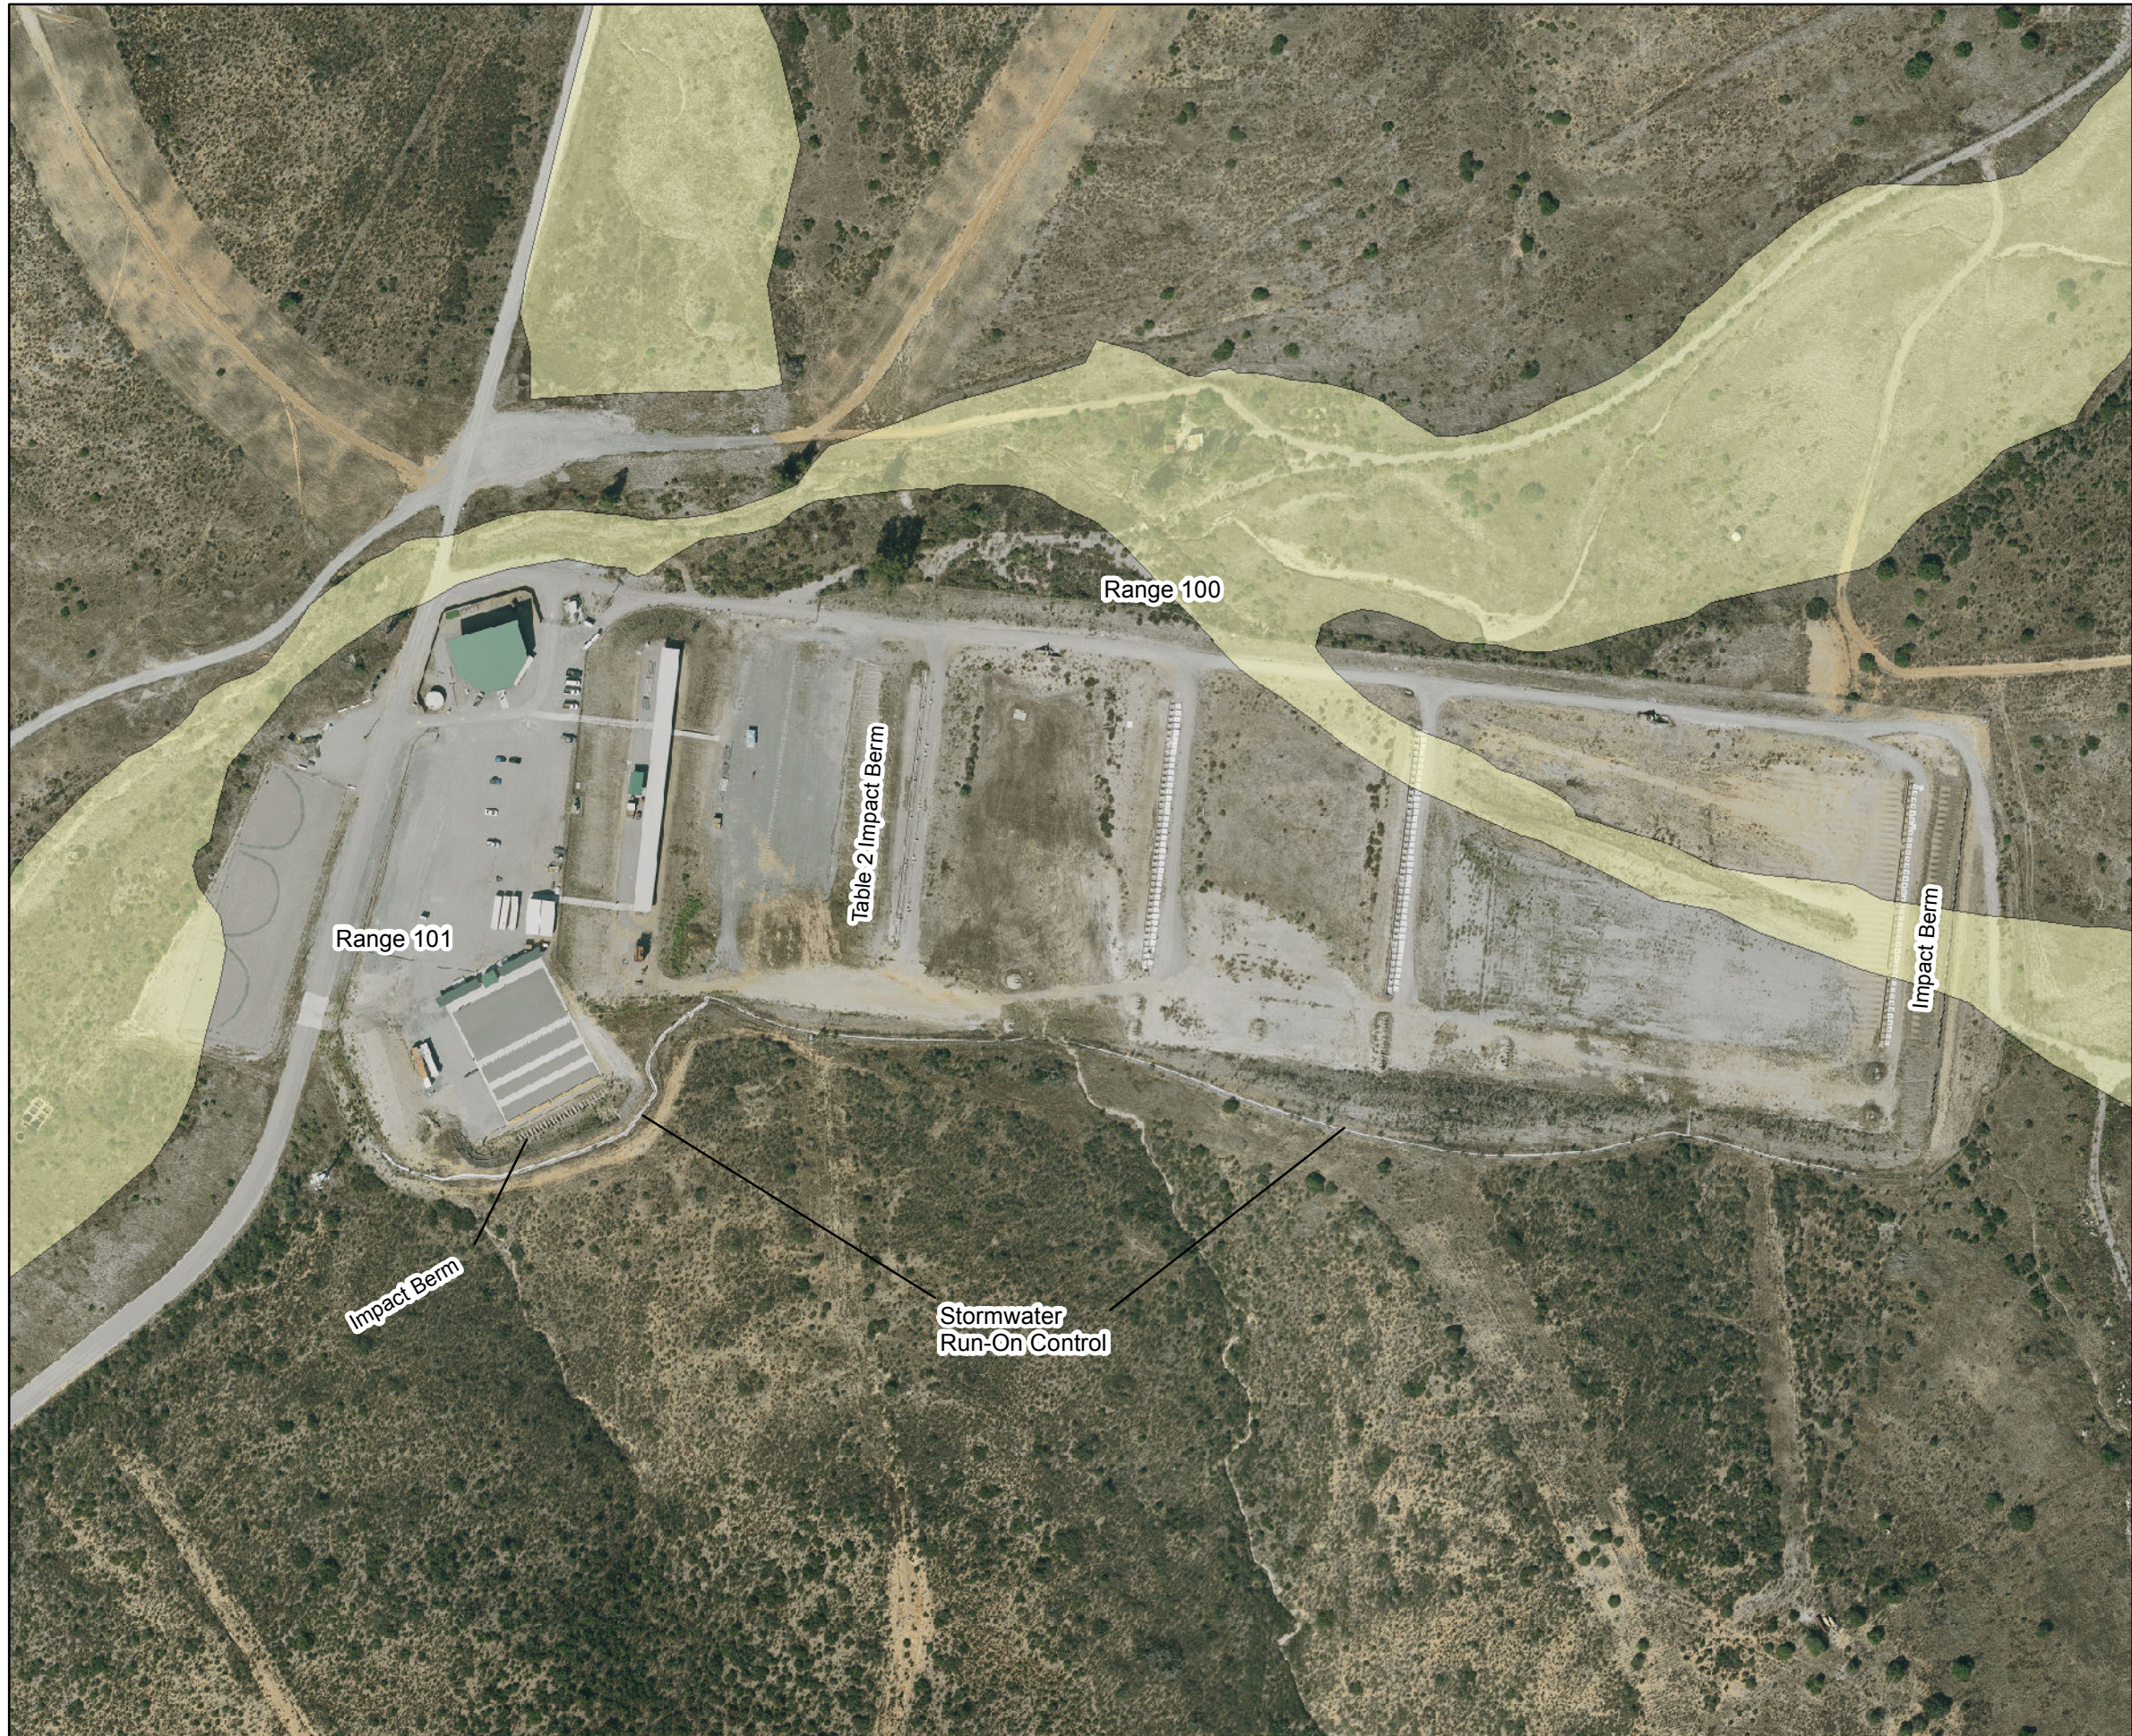
REVA
Figure 7-1
Ranges 100 and 101

Range 100, also known as the LOMAH Rifle Range, is a 500-yard rifle range located in the north-central section of East Miramar and, along with Range 101, comprises the Carlos Hathcock Range Complex. The location of Range 100 is shown in **Figure 7-1**. The range is operated as part of the MTU and was constructed in 2004. It is oriented for firing from east to west. Its SDZ partially overlaps Training Areas 1 and 2 and the EOD Training Range. The range contains 40 firing lanes of multiple known distance targets, as well as eight lanes for unknown distance targets. Targets are located at distances of 100, 200, 300, and 500 yards from the firing line. The targets used in the LOMAH system electronically gauge the location of hits and misses on the target and report scores in real time. The range is used approximately 3 weeks per month. In addition, Table 2 rifle training has been initiated, with Marines firing into the base of the earthen

Range 101 is located immediately southwest of and adjacent to Range 100 in the north-central section of the East Miramar Range Complex, as shown in **Figure 7-1**. It is also part of the Carlos Hathcock Range Complex and MTU operations. This pistol range opened in January 2007 and contains 25 firing lanes at 7, 15, 25, and 50 yard distances. Shotgun training also is conducted at this range. Firing is directed to the southeast, where a natural hillside serves as the rear impact berm for bullet containment. The slope of the hillside berm is steep, and significant erosion or the impact berm face was evident. Various types of small arms ammunition are expended at this range. Range 101 had a similar rate of lead deposition per year during the five-year review period as Range 100 (approximately 8,620 lb/yr); however, where lead is dispersed across two impact berms at Range 100, it is directed into a smaller, single berm at Range 101. Lead recovery activities never have been conducted at Range 101. Range maintenance activities involving lead recovery and berm reconstruction are in the planning stages for this range. According to Range Operations personnel, the funds are in place and the lead recovery is likely to start in the near future.

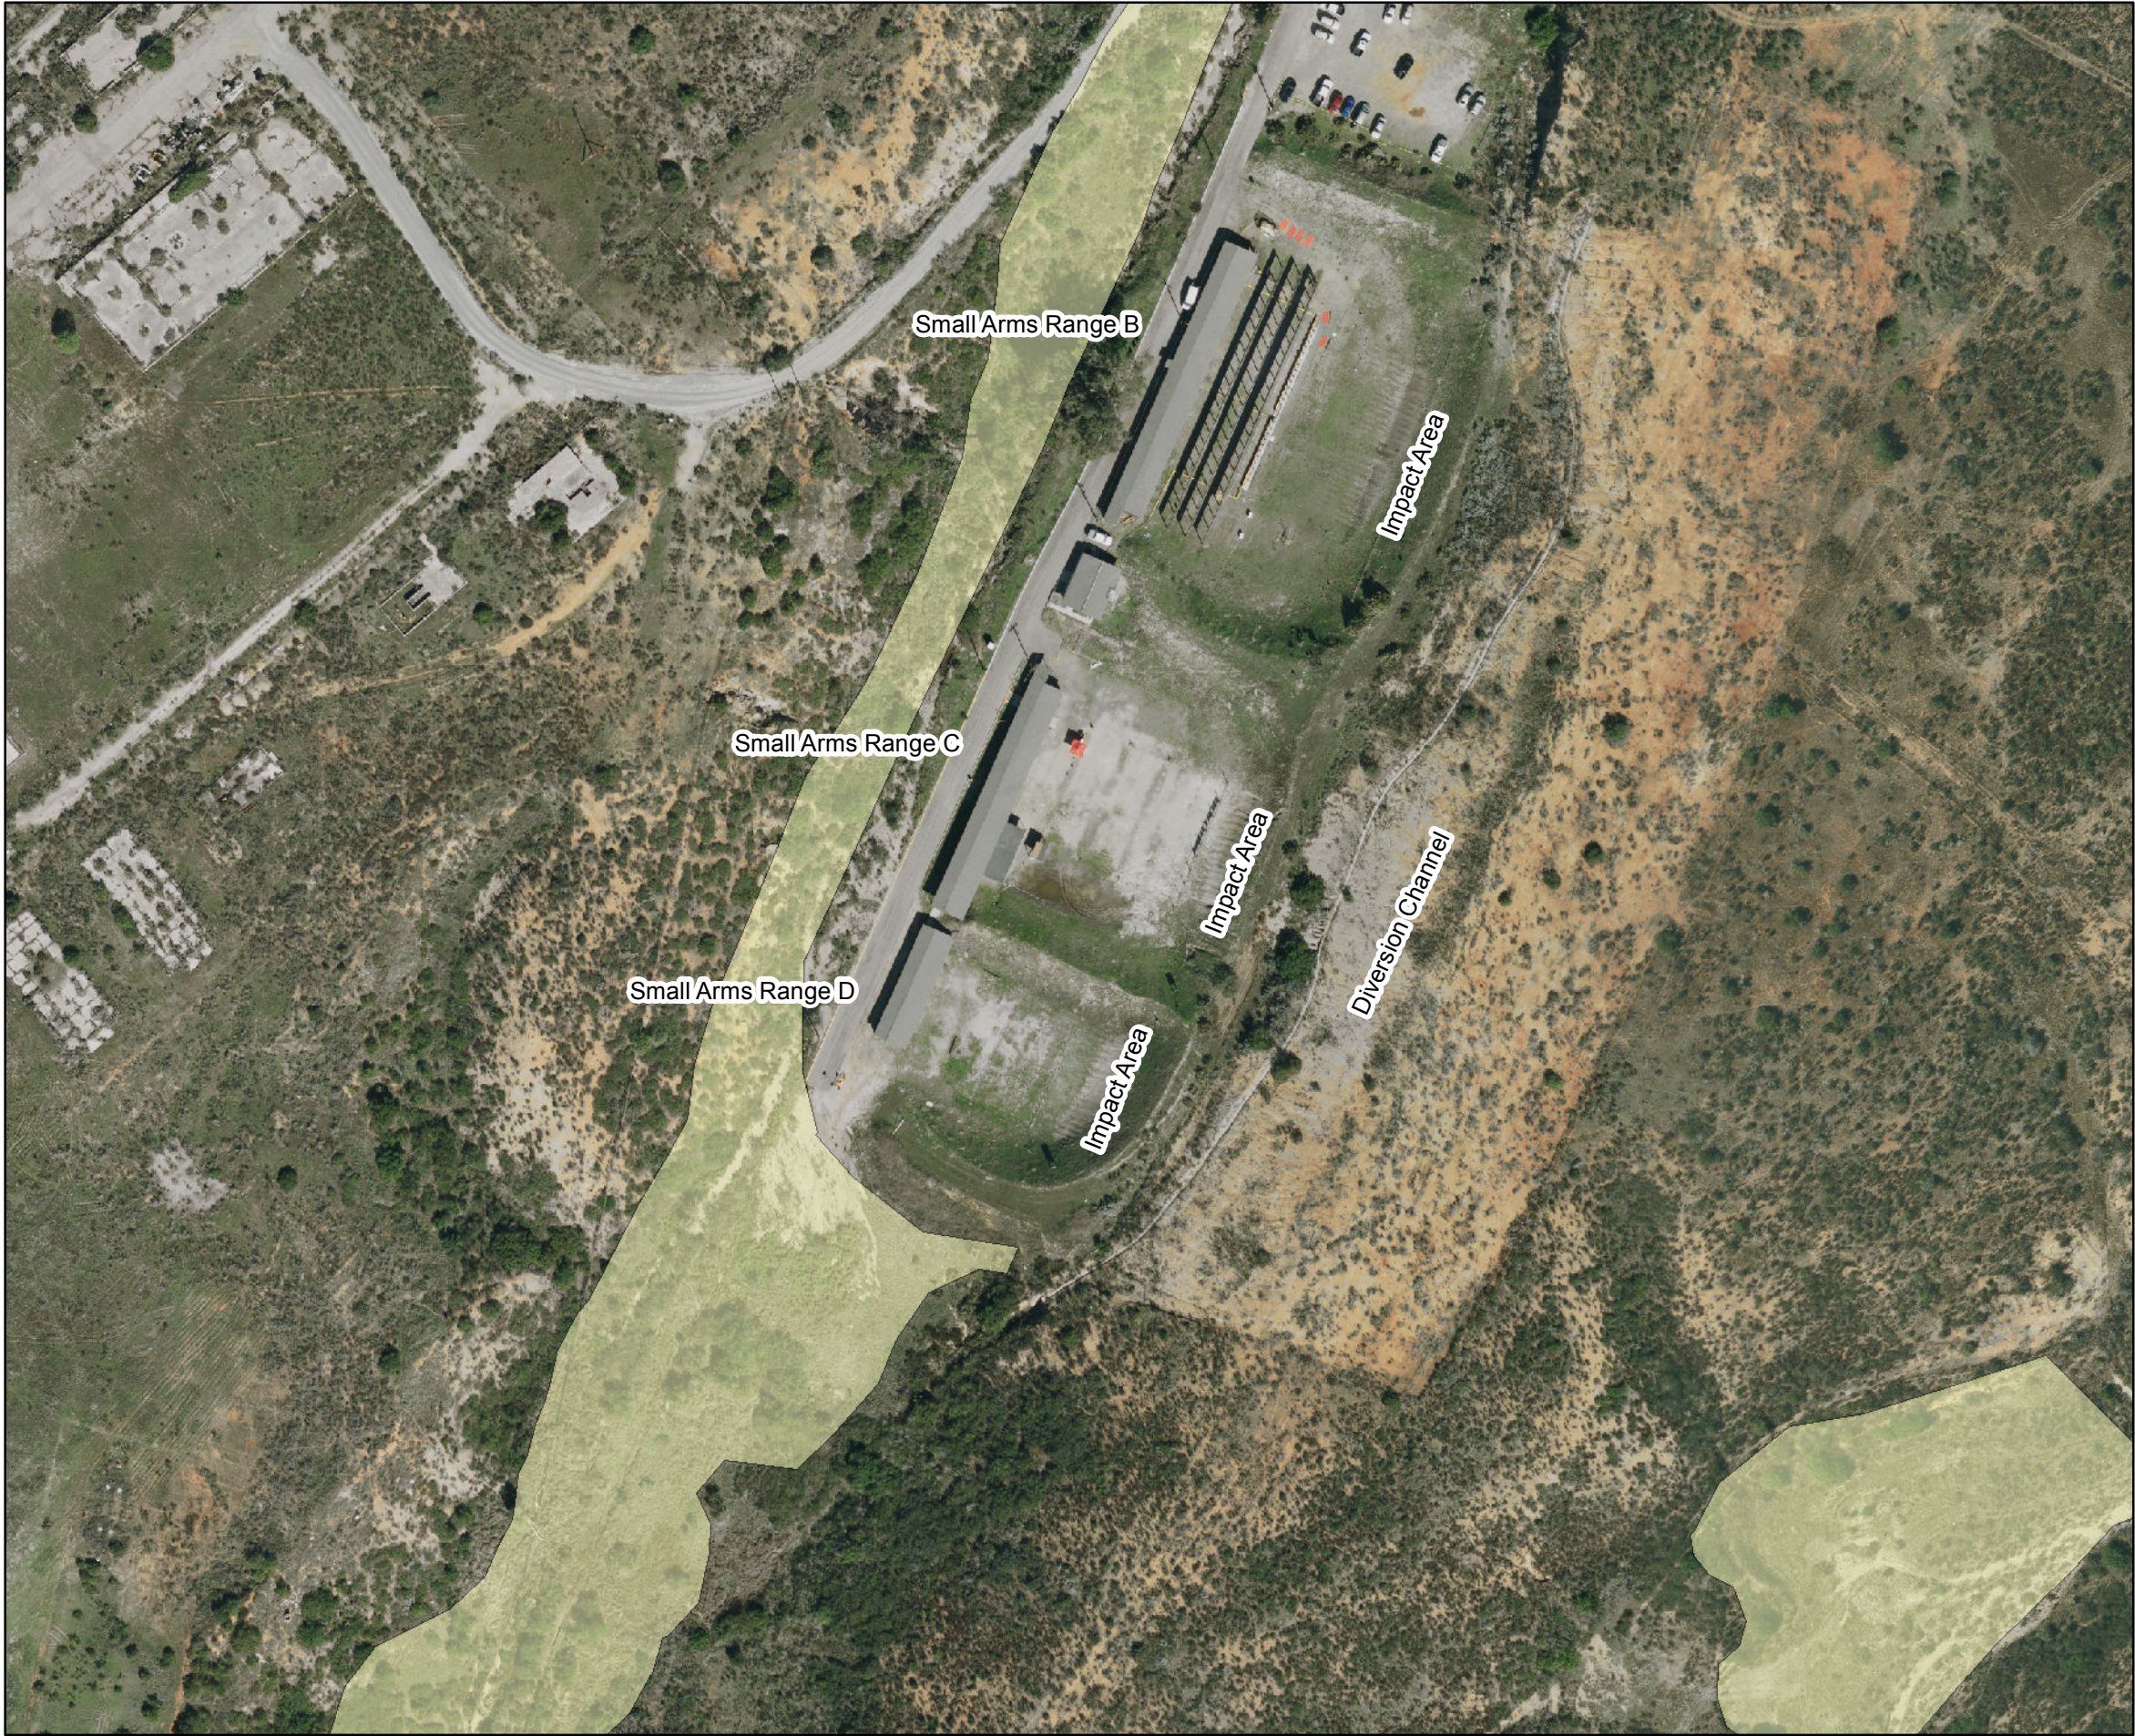
REVA
Figure 7-2
Ranges B, C, and D

Ranges B, C, and D are located in the southwestern section of East Miramar adjacent to Training Area 5, as shown in **Figure 7-2**. The ranges, located in parallel along a north-south trending hillside, are oriented for firing to the east-southeast. The ranges are separated by earthen side berms, and the natural hillside serves as the rear impact berm for all three ranges. In addition, Range B contains wood baffling above the rear firing line to reduce the vertical trajectory of bullets fired during training. All three ranges are used frequently.

Range B is approximately 300 ft wide and contains 22 firing positions at distances of 35, 40, and 50 yards. Range B has wooden baffling above the rear of the firing line to reduce the vertical trajectory of small arms projectiles fired during training. Range C, approximately 200 ft wide, contains 26 firing positions at distances of 9, 15, 25, and 35 yards. Range D, approximately 100 ft in width, contains 20 firing positions at 7, 11, and 25 yards. All targets are comprised of paper set on wooden frames in front of the impact berm. A combined SDZ has been established for the three Marine Corps ranges and the four San Diego County Sheriff's Department's ranges, which

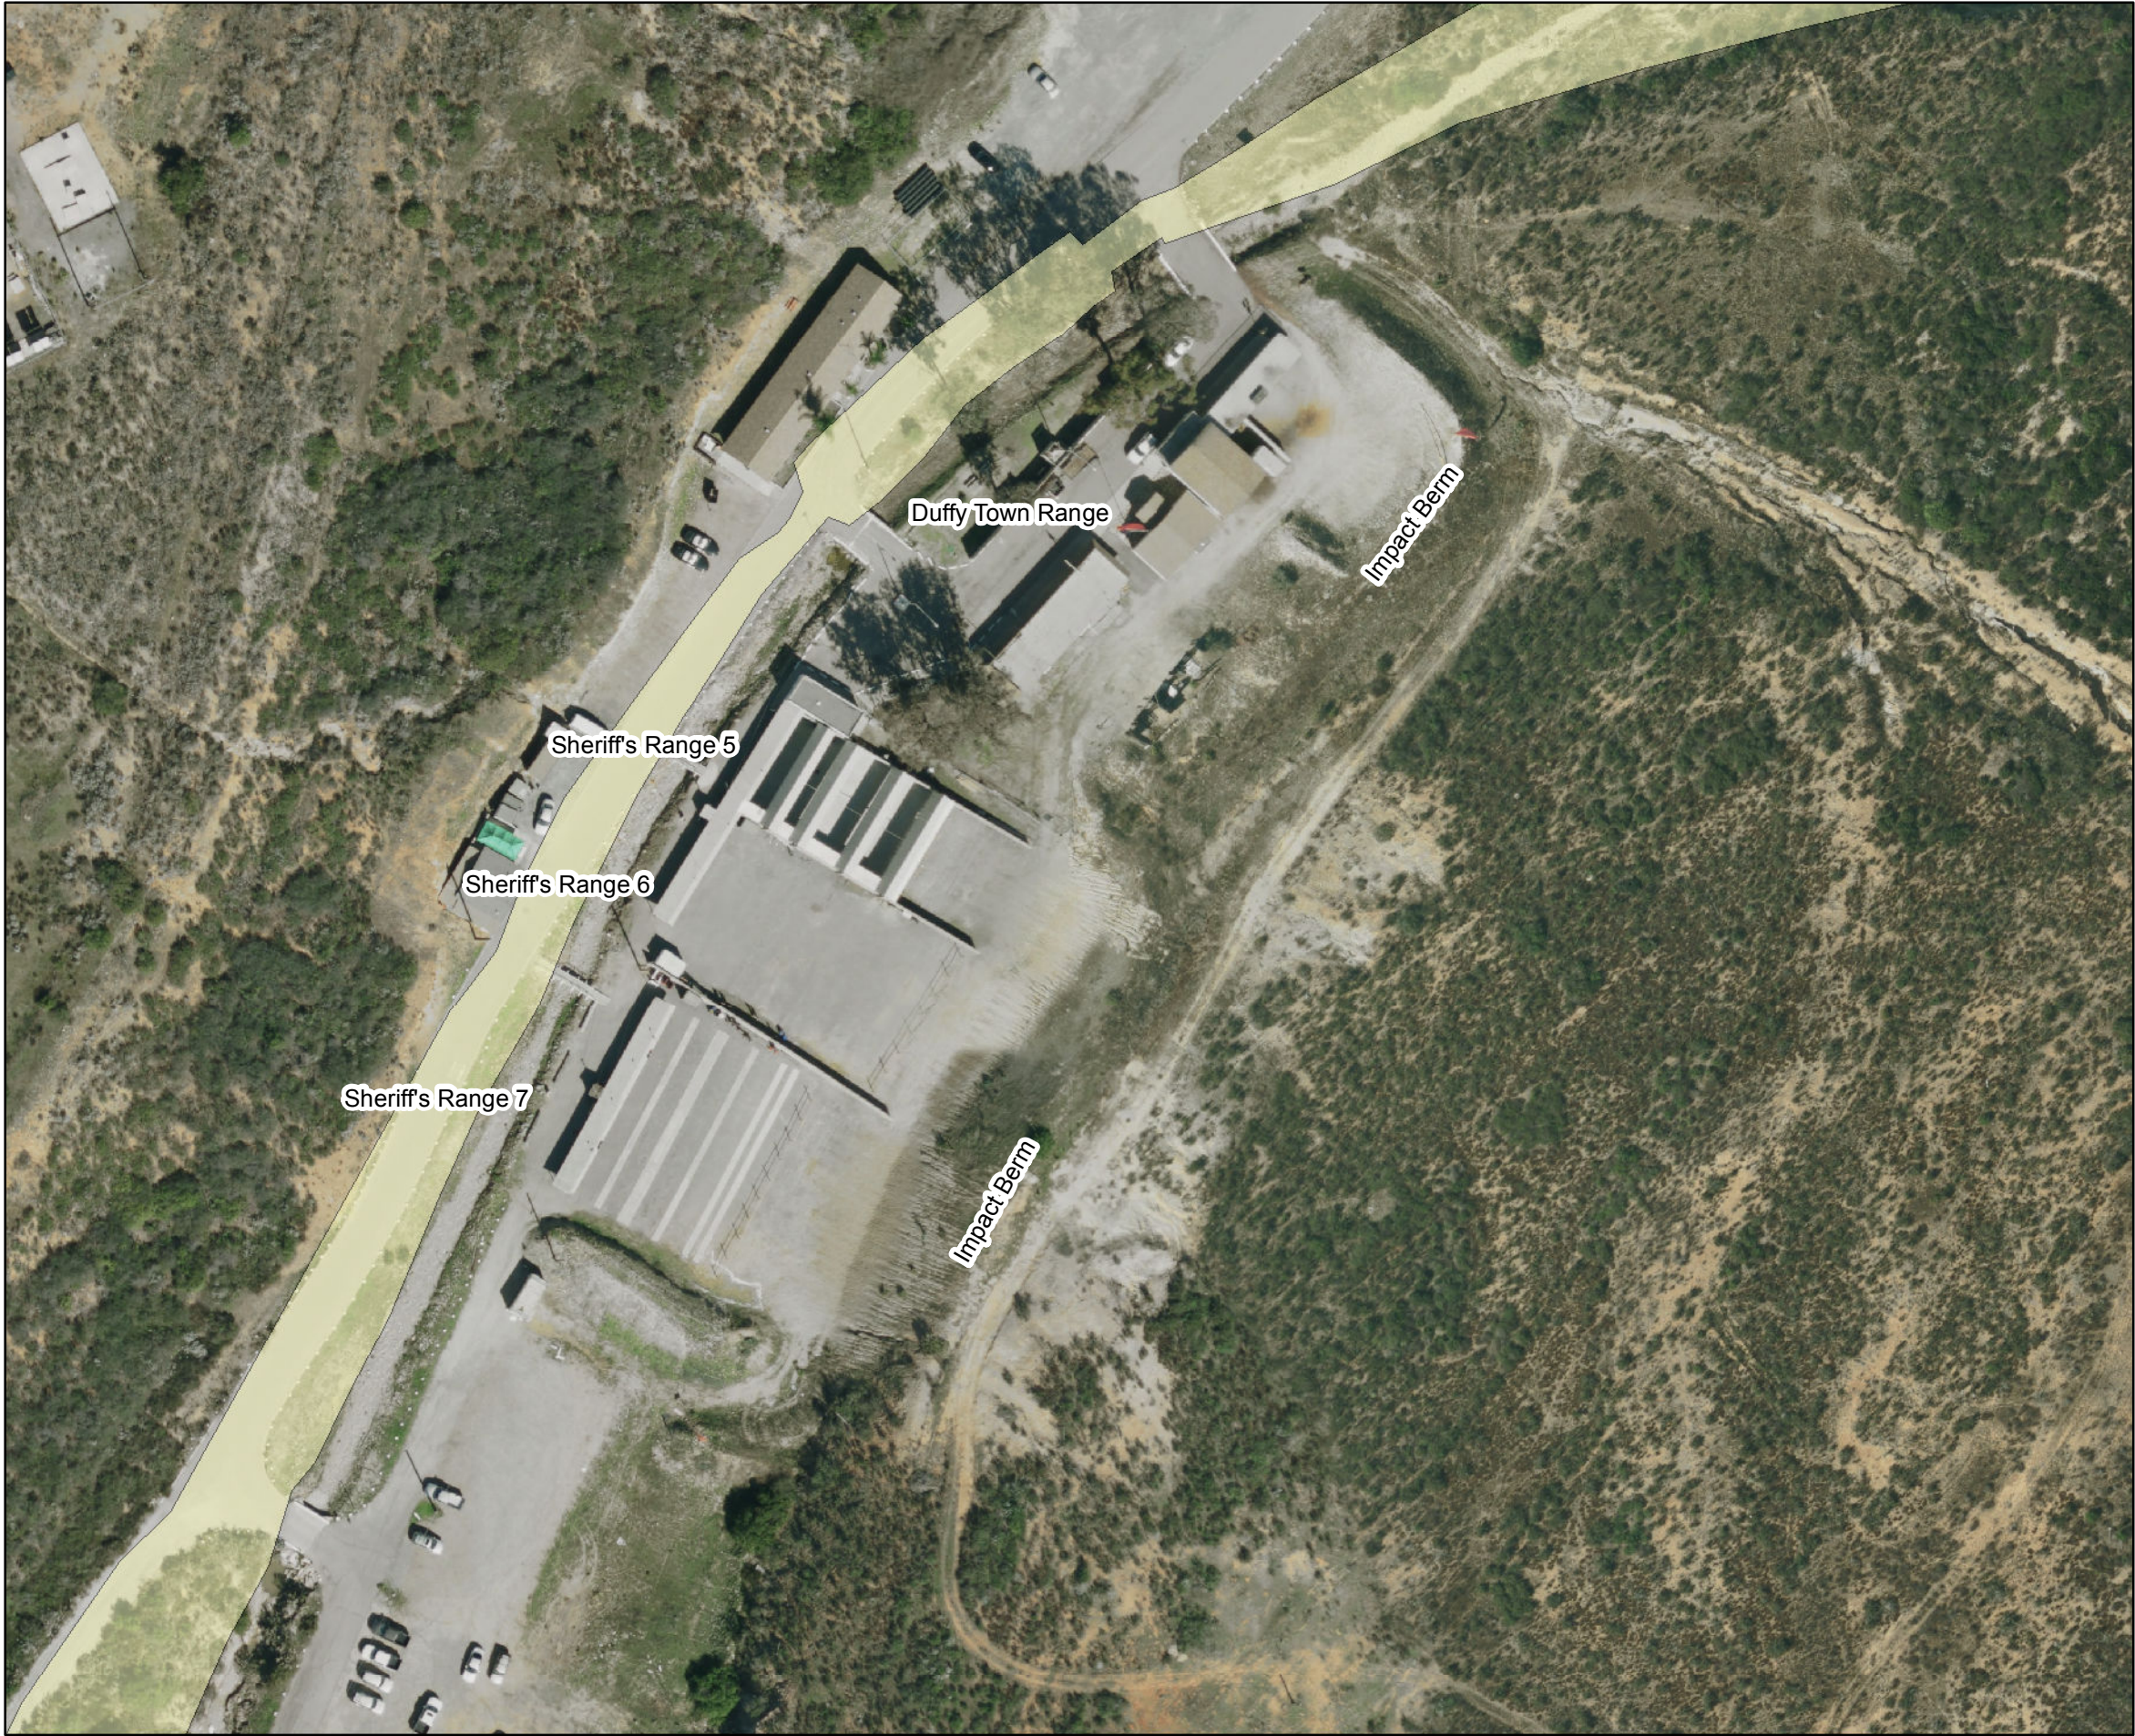
REVA
Figure 7-3
Ranges 5, 6, 7, and the
Duffy Town Range

fire training exercises, and to practice rescue training techniques. The four SARs (Ranges 5, 6, 7, and Duffy Town) are located within this facility, directly north of Ranges B, C, and D (**Figure 7-3**). The facility is composed of a dog training facility, an urban disaster training facility, an obstacle course, a mock town (known as Duffy Town) used for tactical training, and administrative buildings (MCAS Miramar, 2011b).

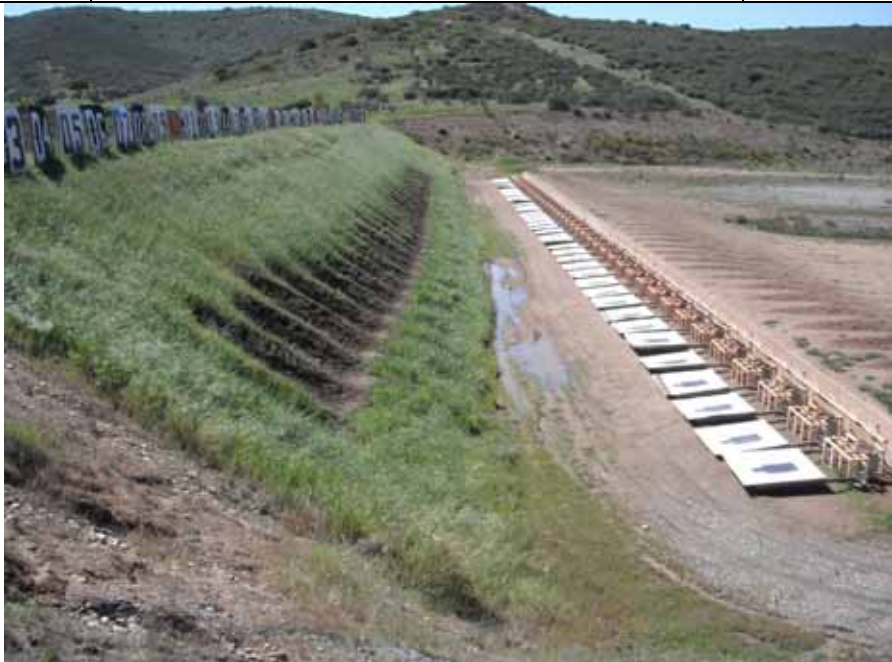
Installation Name: MCAS Miramar		Site Name: Range 100		Location: San Diego, CA
Photo No. 2	Date: 3/20/2012

Direction Photo Taken: South				
Description: View of the rear backstop berm of Range 100.

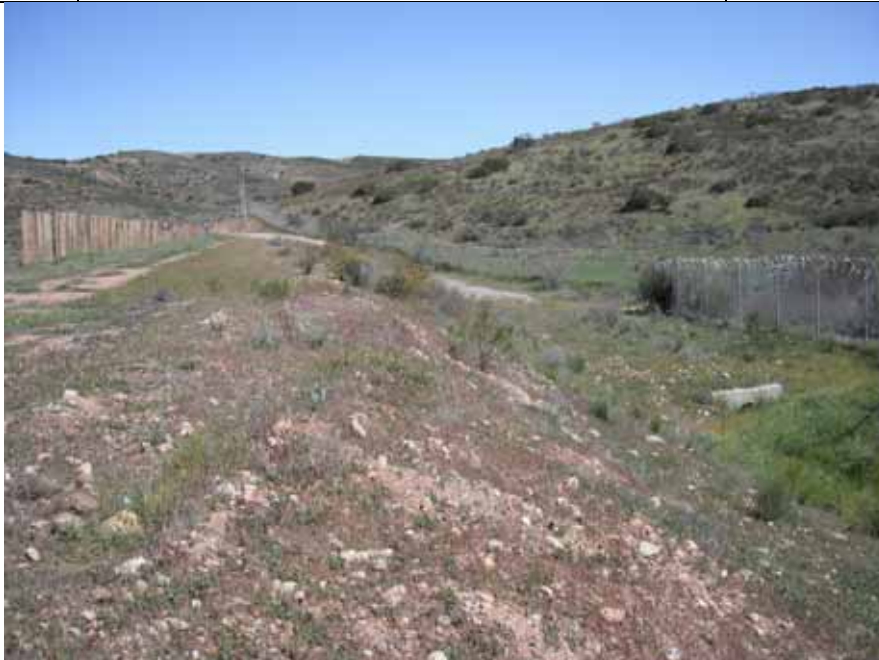
Installation Name: MCAS Miramar		Site Name: Range 100		Location: San Diego, CA
Photo No. 4	Date: 3/20/2012

Direction Photo Taken: North				
Description: View of top and behind the rear backstop berm of Range 100.

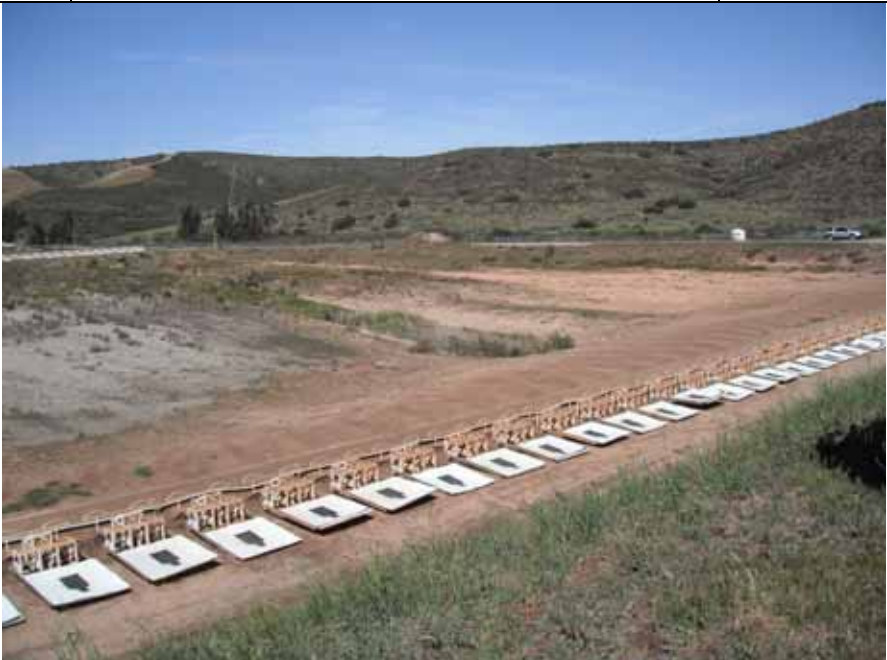
Installation Name: MCAS Miramar		Site Name: Range 100		Location: San Diego, CA
Photo No. 6	Date: 3/20/2012

Direction Photo Taken: Northwest				
Description: View of drainage channel in middle of Range 100 with mechanical targets at base of rear backstop berm in foreground.

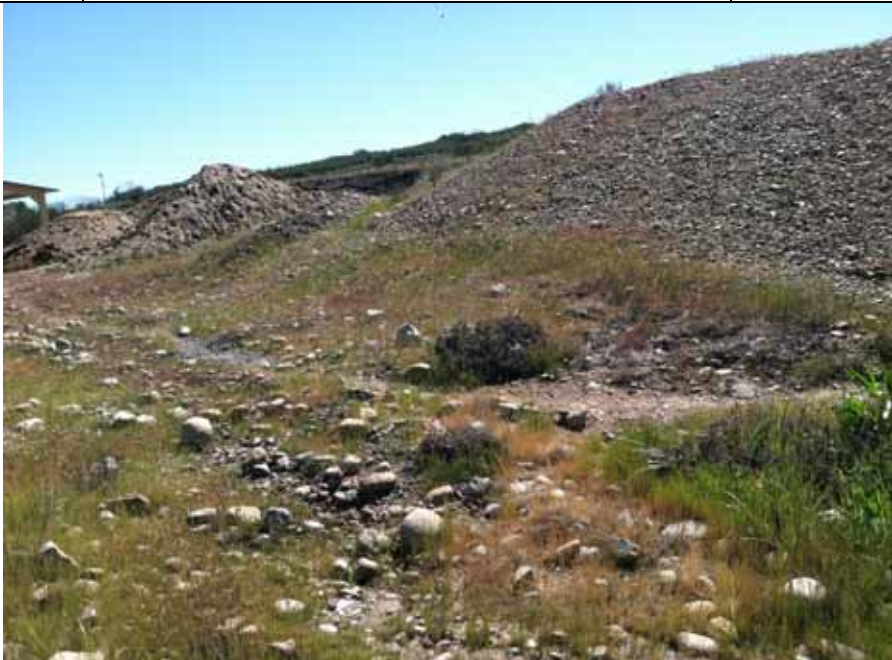
Installation Name: MCAS Miramar		Site Name: Range 101		Location: San Diego, CA
Photo No. 13	Date: 3/20/2012

Direction Photo Taken: East				
Description: View of outfall with Range 101 in the background.

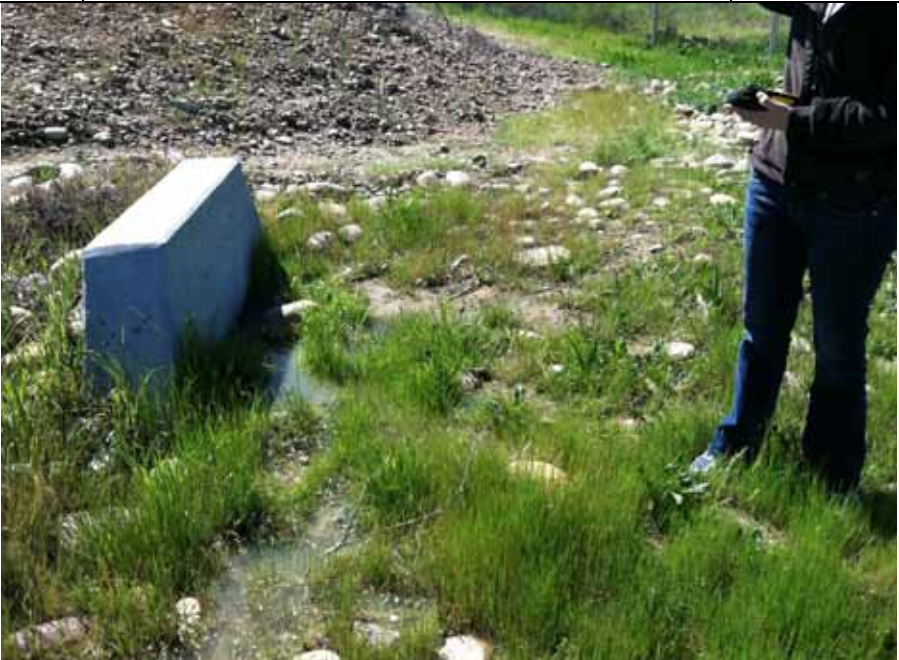
Installation Name: MCAS Miramar		Site Name: Range 101		Location: San Diego, CA
Photo No. 15	Date: 3/20/2012

Direction Photo Taken: South				
Description: Outfall of inlet at foot of impact berm at Range 101.

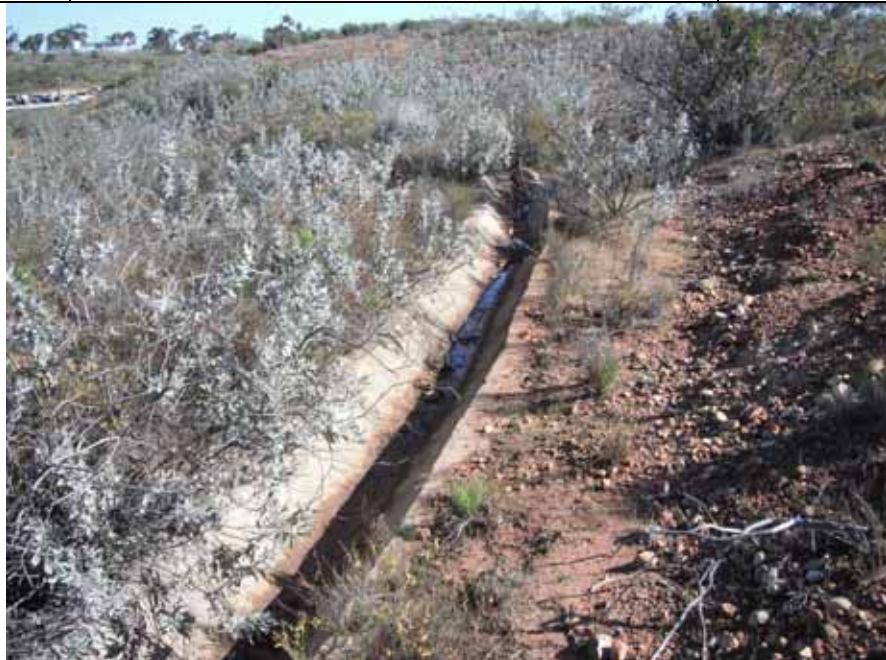
Installation Name: MCAS Miramar		Site Name: Range B		Location: San Diego, CA
Photo No. 18	Date: 3/20/2012

Direction Photo Taken: Northeast				
Description: View of concrete-lined channel running above Range B.

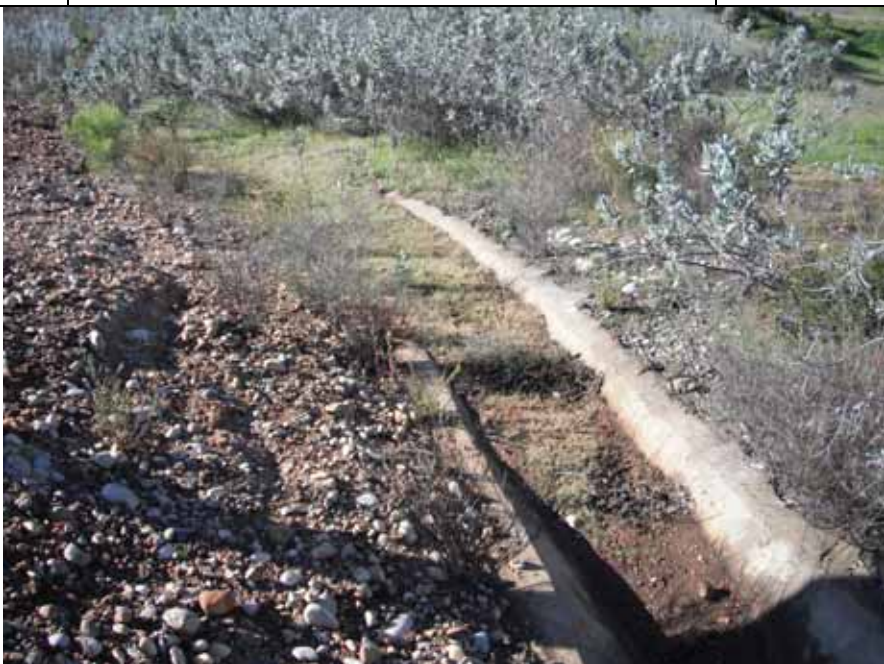
Installation Name: MCAS Miramar		Site Name: Range B		Location: San Diego, CA
Photo No. 19	Date: 3/20/2012

Direction Photo Taken: South				
Description: View of sediment blockage observed in northernmost section of concrete-lined channel above Range B impact berm.

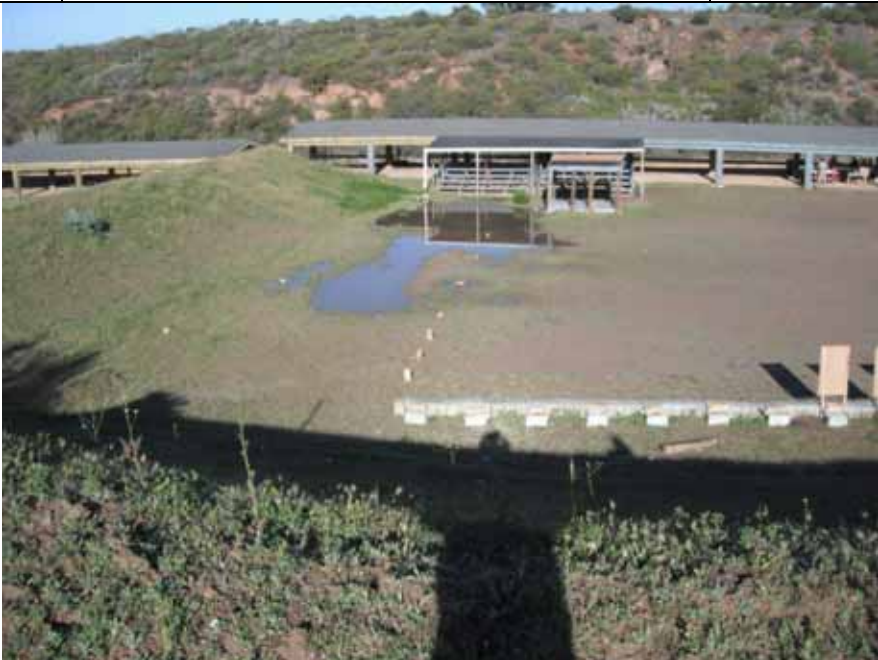
Installation Name: MCAS Miramar		Site Name: Range C	Location: San Diego, CA
Photo No. 23	Date: 3/20/2012

Direction Photo Taken: West			
Description: View of standing water after heavy precipitation event in southern side of Range C.

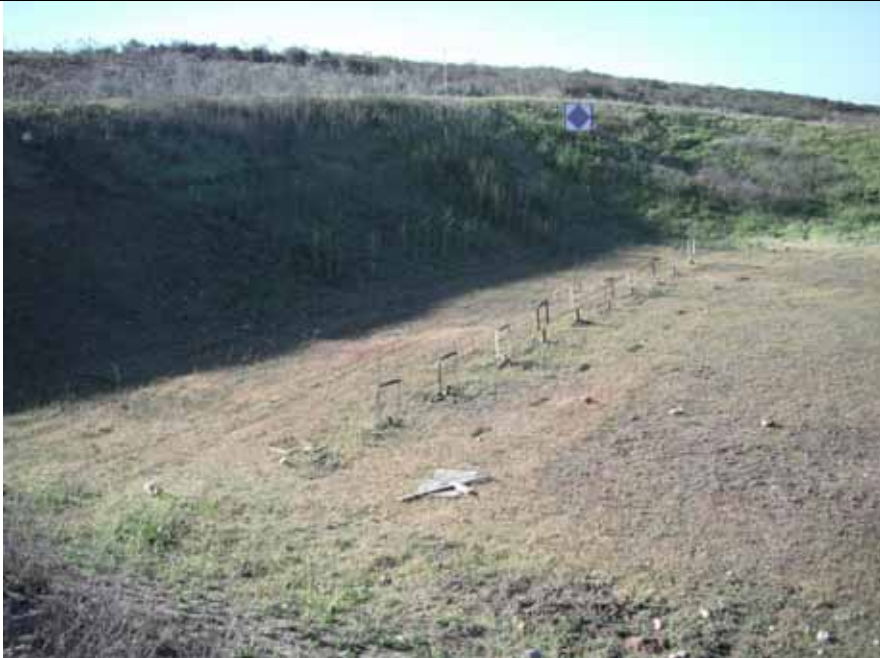
Installation Name: MCAS Miramar		Site Name: Range D	Location: San Diego, CA
Photo No. 25	Date: 3/20/2012

Direction Photo Taken: Southeast			
Description: View of target area and impact berm at Range D.

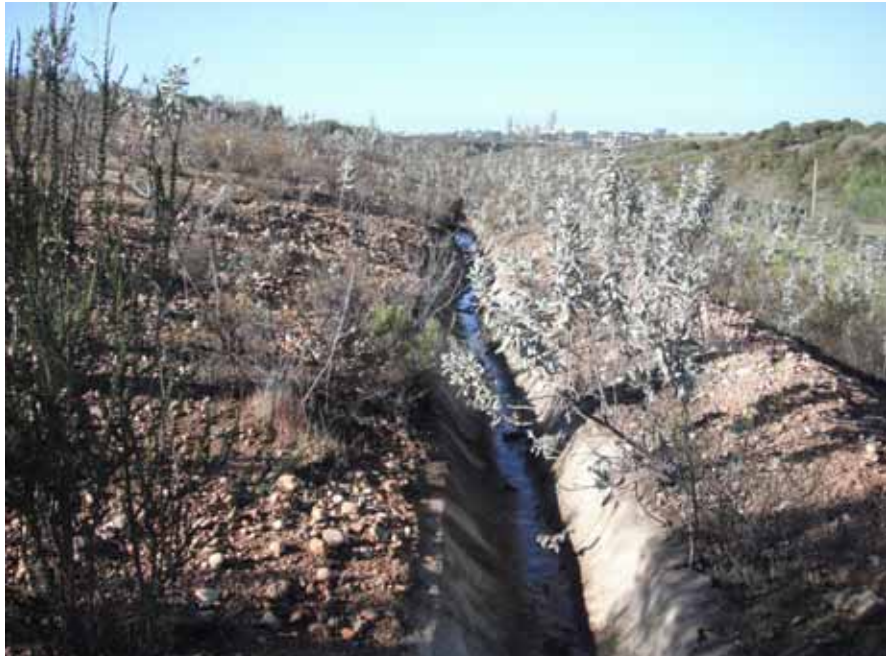
Installation Name: MCAS Miramar		Site Name: Range D		Location: San Diego, CA
Photo No. 28	Date: 3/20/2012

Direction Photo Taken: South				
Description: View of concrete-lined channel that runs above Ranges B, C, and D.
