Range Environmental Vulnerability Assessment

5-Year Review Report

Marine Corps Air Station Miramar, California

June 2013
06285037.0000

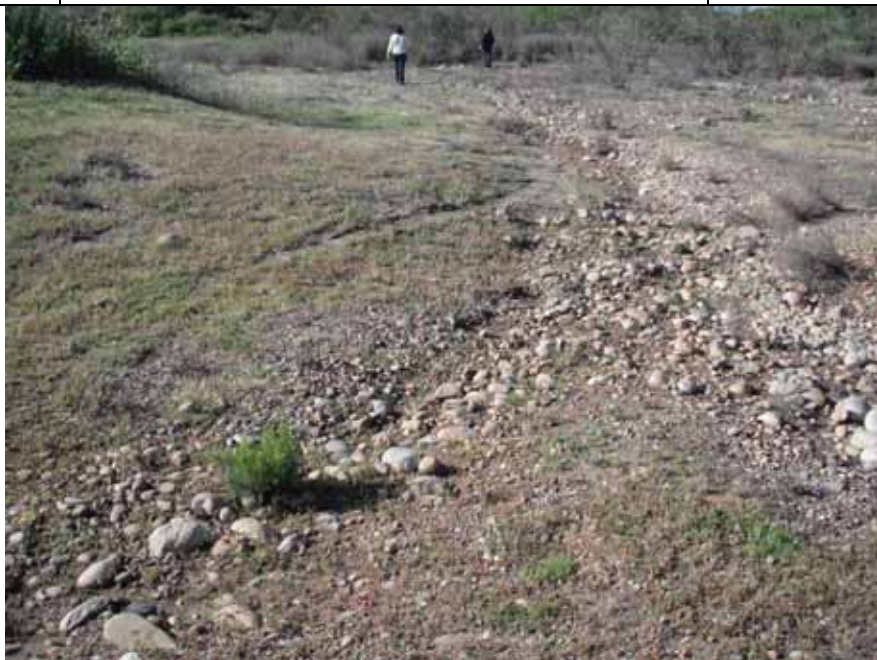
Installation Name: MCAS Miramar		Site Name: Range D		Location: San Diego, CA
Photo No. 30	Date: 3/20/2012

Direction Photo Taken: South				
Description: View of outfall to Murphy Canyon ephemeral stream adjacent to Range D.

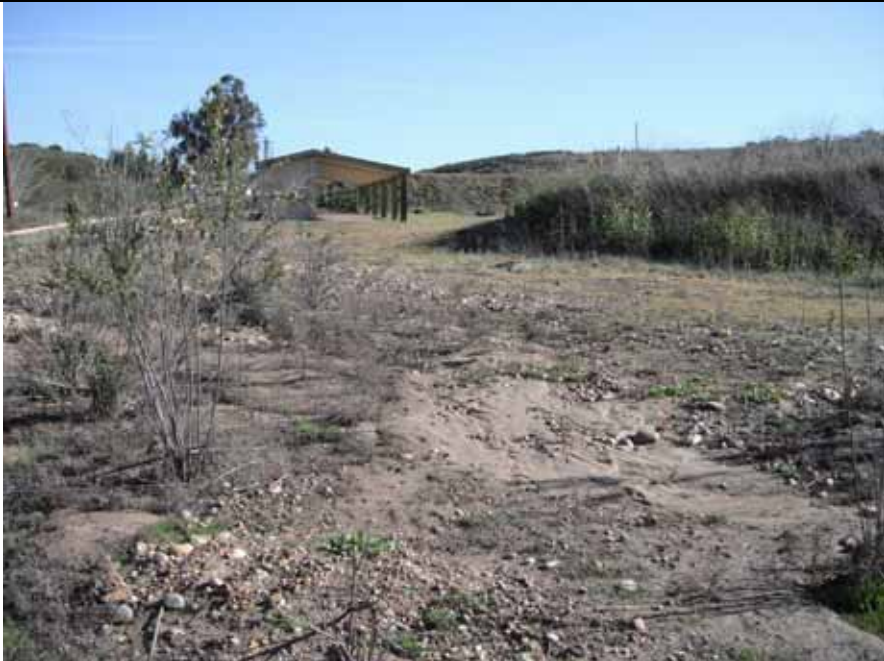
Installation Name: MCAS Miramar		Site Name: Range D	Location: San Diego, CA
Photo No. 31	Date: 3/20/2012

Direction Photo Taken: North			
Description: View of outfall to Murphy Canyon ephemeral stream with Range D in the background.

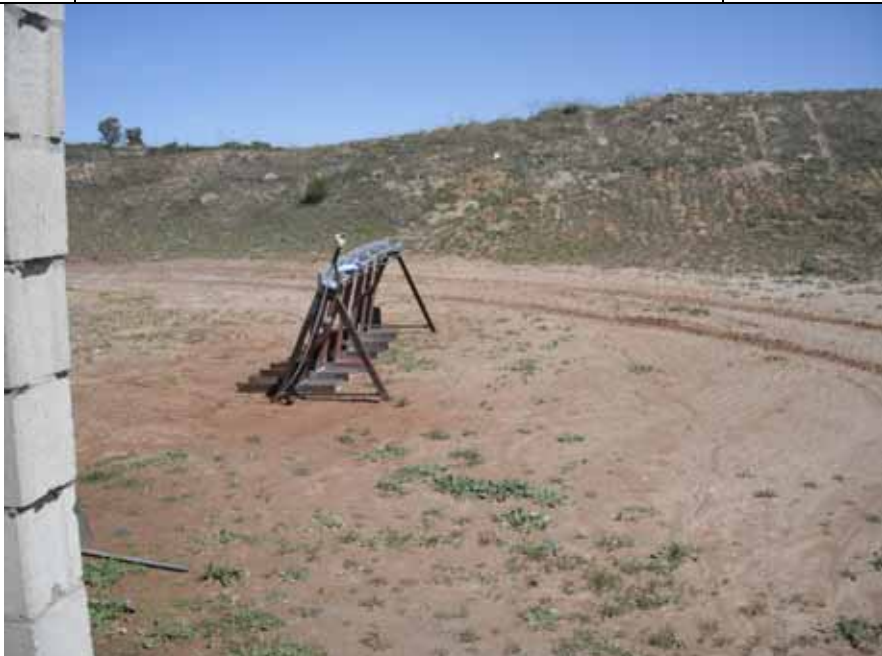
Installation Name: MCAS Miramar		Site Name: Duffytown Range	Location: San Diego, CA
Photo No. 32	Date: 3/20/2012

Direction Photo Taken: Northeast			
Description: View of bullet-capturing targets set up at Duffytown Range.

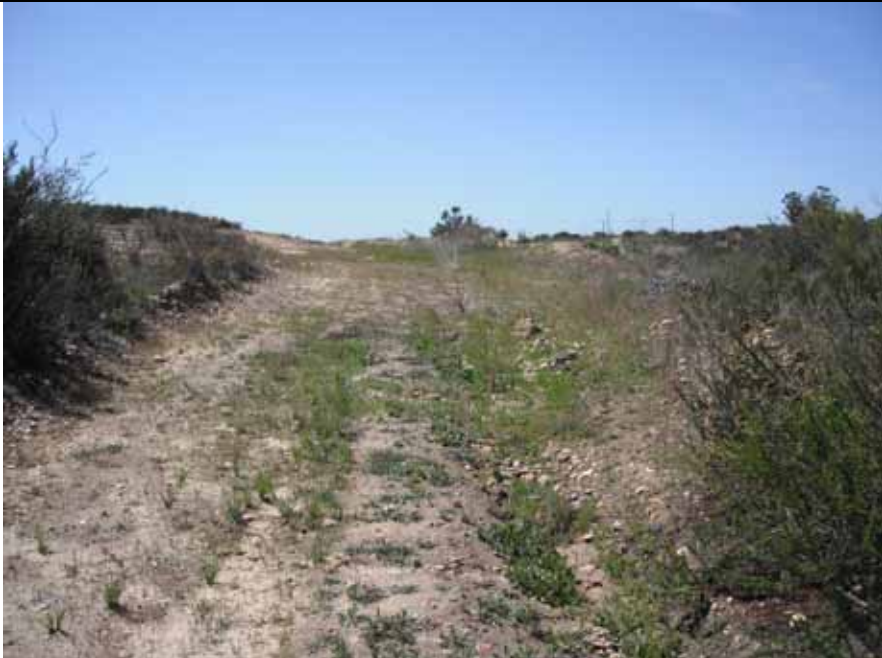
Installation Name: MCAS Miramar		Site Name: Duffytown Range		Location: San Diego, CA
Photo No. 35	Date: 3/20/2012

Direction Photo Taken: Southwest				
Description: View of natural ephemeral drainage that runs behind the Duffytown Range impact berm as well as the impact berms on Ranges 5, 6, and 7. It drains into the Murphy Canyon ephemeral stream adjacent to the Duffytown Range seen in Photo No. 36.

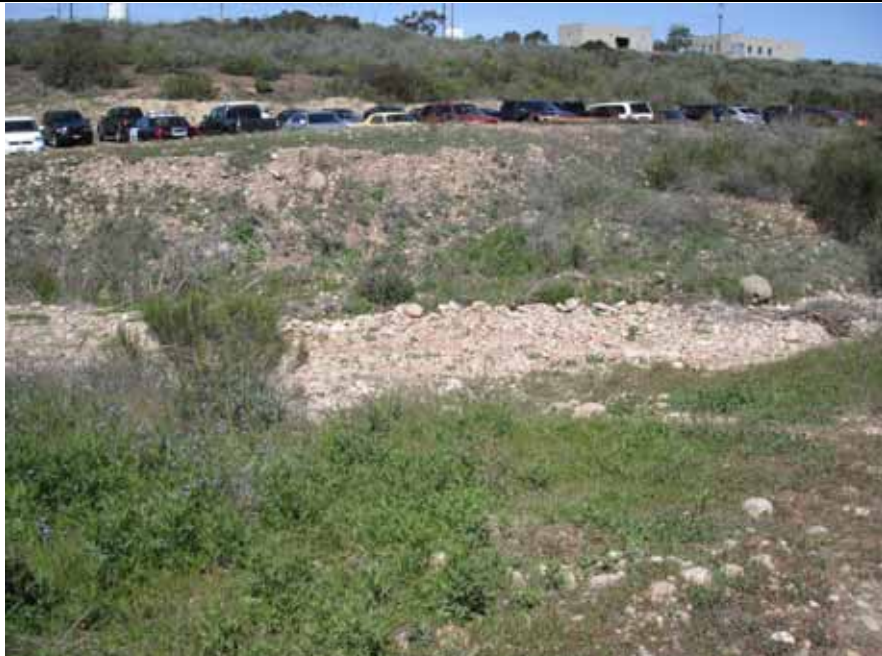
Installation Name: MCAS Miramar		Site Name: Duffytown Range		Location: San Diego, CA
Photo No. 36	Date: 3/20/2012

Direction Photo Taken: Northwest				
Description: View of outfall for drainage from natural ephemeral stream that runs behind impact berms of Ranges 5, 6, 7, and the Duffytown Range.

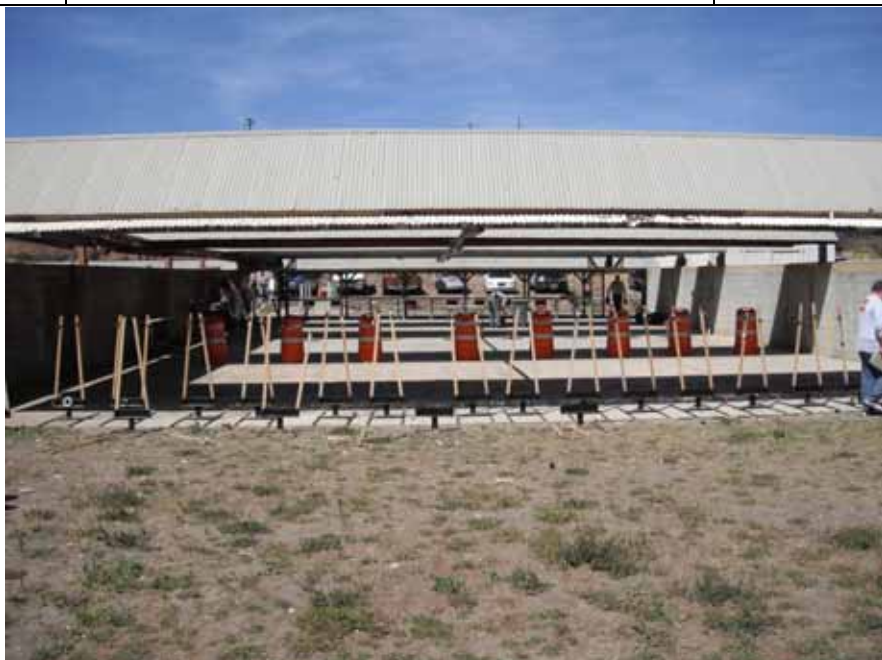
Installation Name: MCAS Miramar		Site Name: Range 5	Location: San Diego, CA
Photo No. 38	Date: 3/20/2012

Direction Photo Taken: Northwest			
Description: <p>View of firing lines, overhead baffling, and target frames of Range 5.</p>

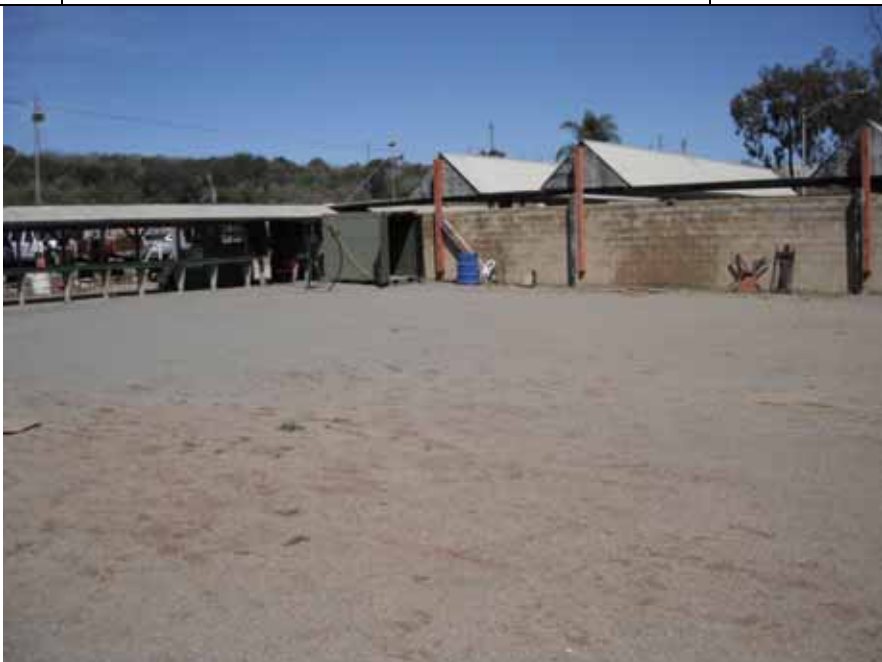
Installation Name: MCAS Miramar		Site Name: Range 6	Location: San Diego, CA
Photo No. 41	Date: 3/20/2012

Direction Photo Taken: North			
Description: View of side wall and firing line at Range 6.

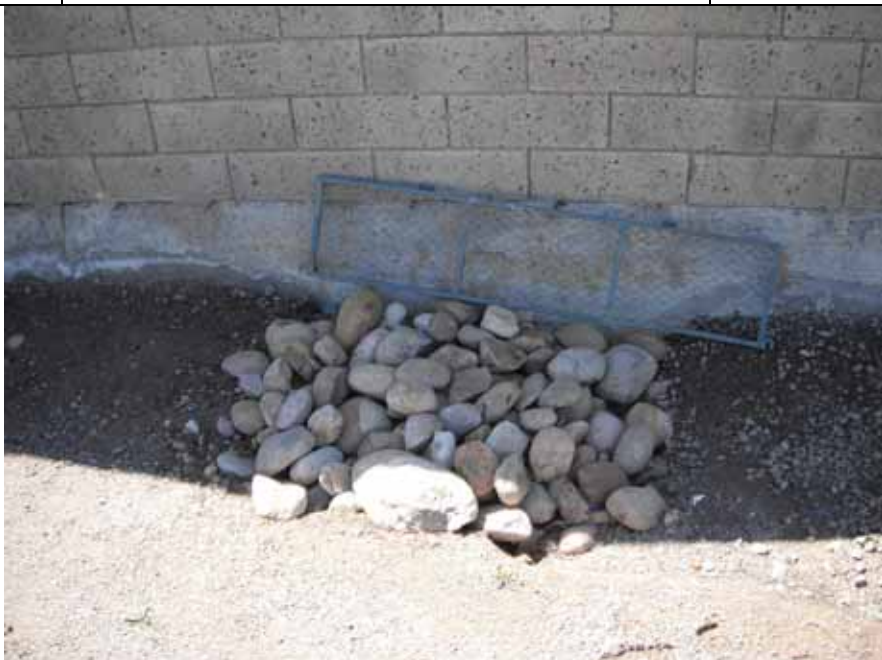
Installation Name: MCAS Miramar		Site Name: Range 6	Location: San Diego, CA
Photo No. 42	Date: 3/20/2012

Direction Photo Taken: Southwest			
Description: Floor drain at the base of the sidewall between Range 6 and Range 7.

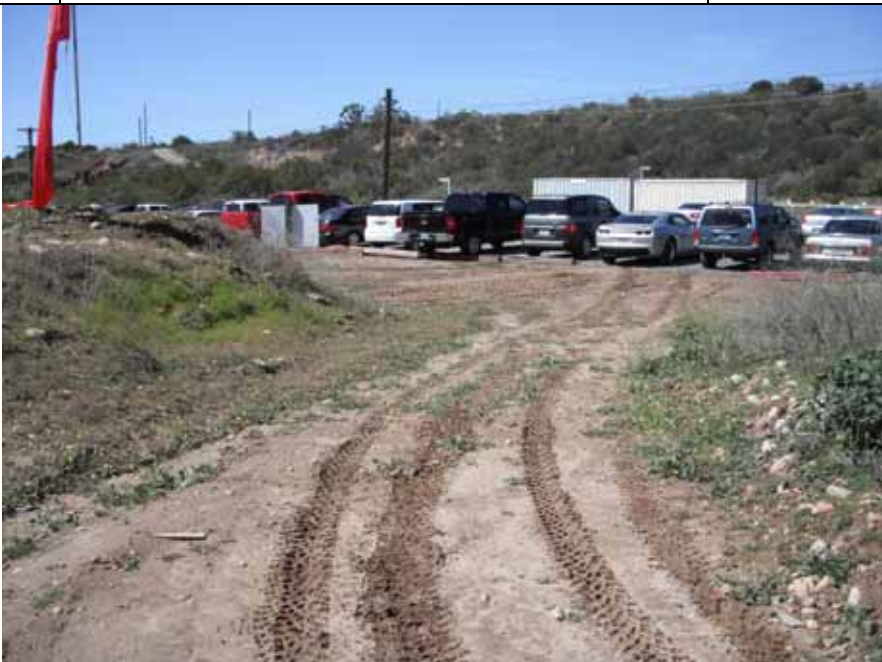
Installation Name: MCAS Miramar		Site Name: Range 7		Location: San Diego, CA
Photo No. 48	Date: 3/20/2012

Direction Photo Taken: West				
Description: View of outfall of drainage trench at foot of impact berms at Ranges 5, 6, 7, and the Duffytown Range.
